CT-62

SPOUT FARM

late 18th. c.

1. STATE Maryland COUNTY Calvert TOWN Sollers VICINITY Sollers STREET NO. Sollers Point Road ORIGINAL OWNER Sollers Family ORIGINAL USE Dwelling PRESENT OWNER Mr. and Mrs. Fuller PRESENT USE Dwelling WALL CONSTRUCTION Clapboard NO. OF STORIES 2½ w/ 1½ addition		HISTORIC AMERICAN BUILDINGS SURVEY INVENTORY CT-62

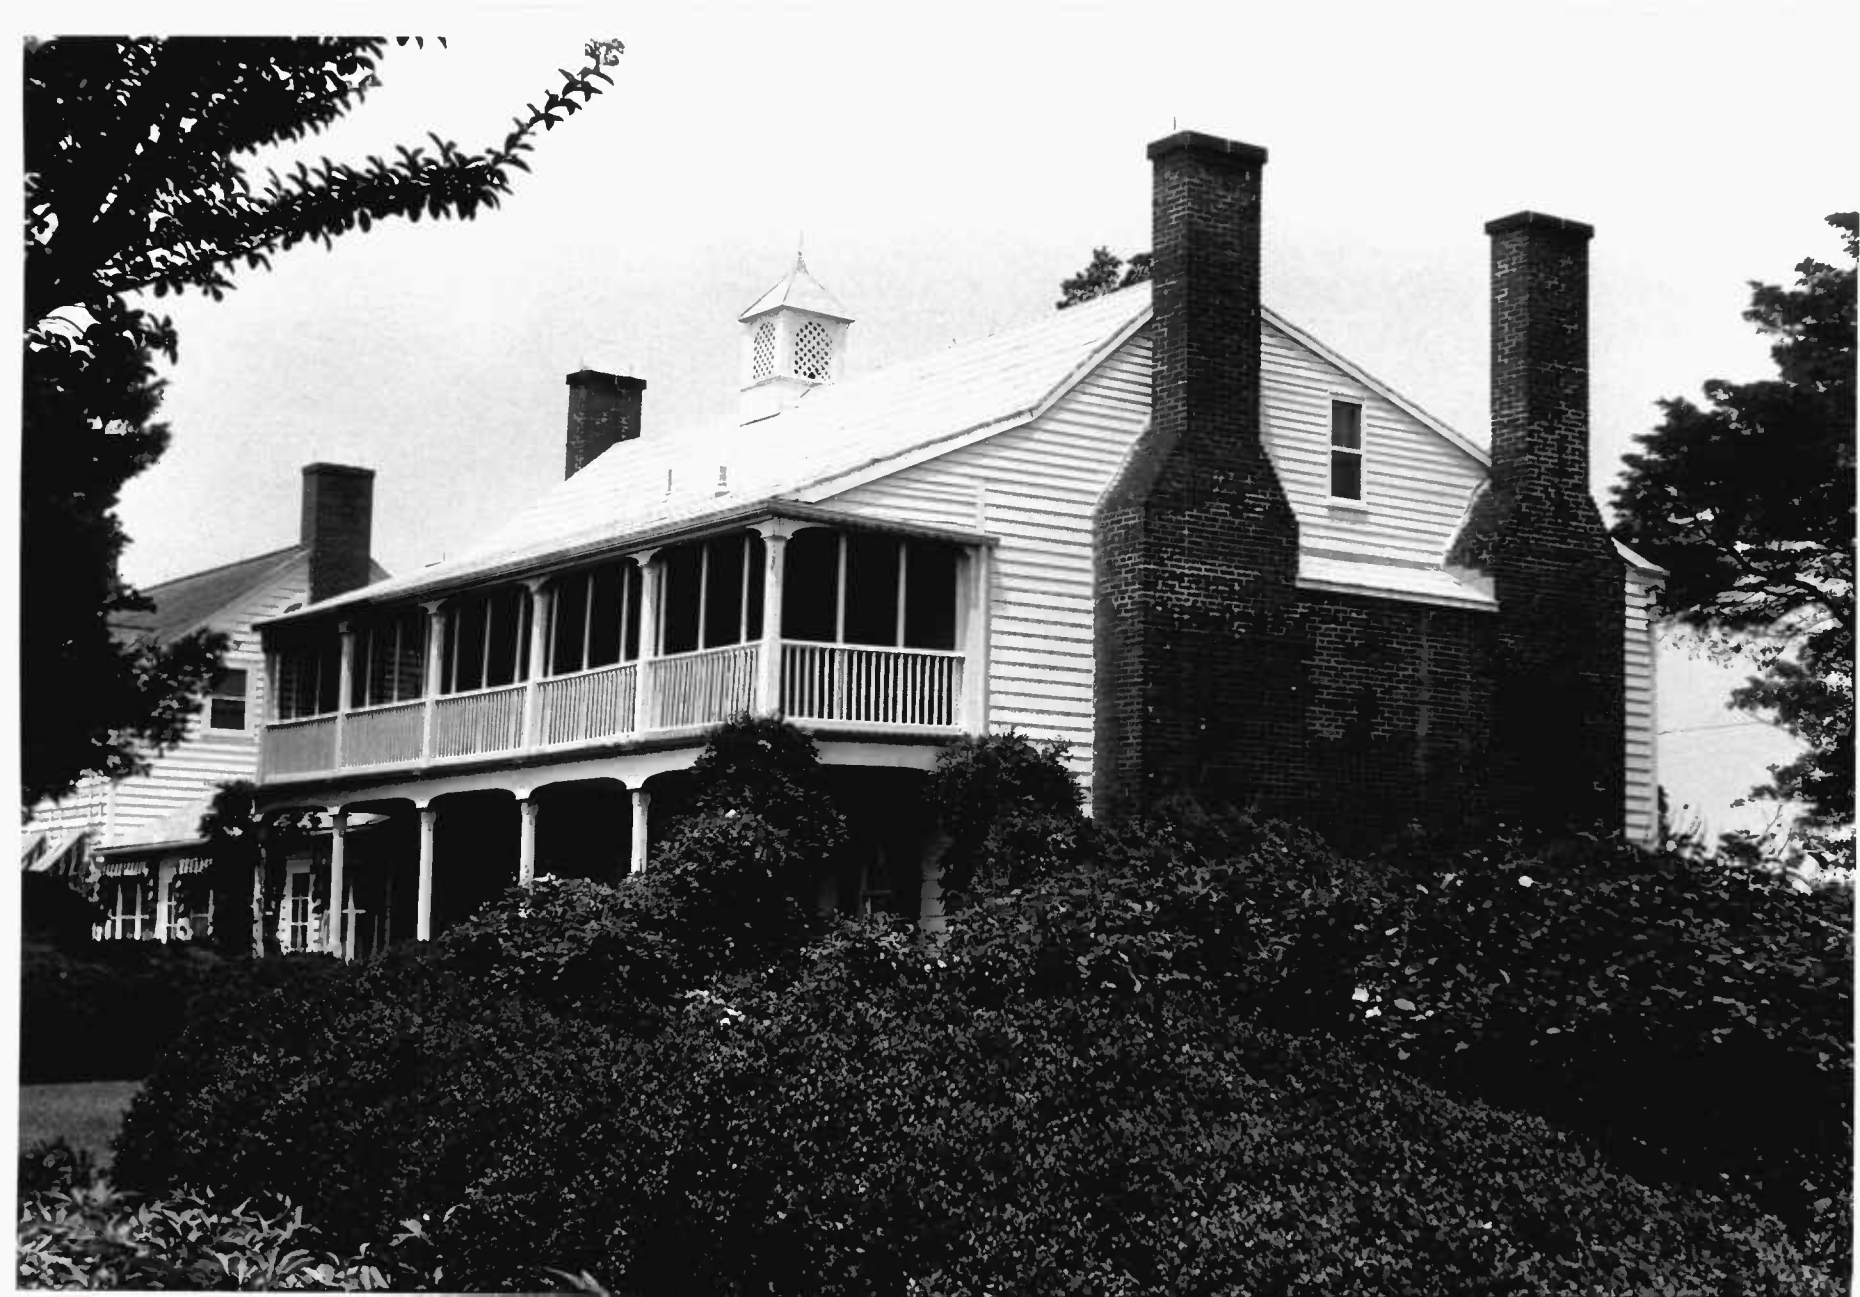
Spout Farm

Attractively situated and surrounded by large plantings of boxwood this two story frame structure has an unusual salt box profile and massive external chimneys with stepped weatherings and two story pents. The two story galleried porch at the principle facade is of a recent date.
